FACT SHEET #3 **BLM, EPA &** **ENVIRONMENTAL** **QUALITY MANAGEMENT** **INC. REMOVE CYANIDE** **CONTAMINATED SOILS** **AT THE** **VETA GRANDE MINE SITE**

Veta Grande Mine Site Fall, 2001

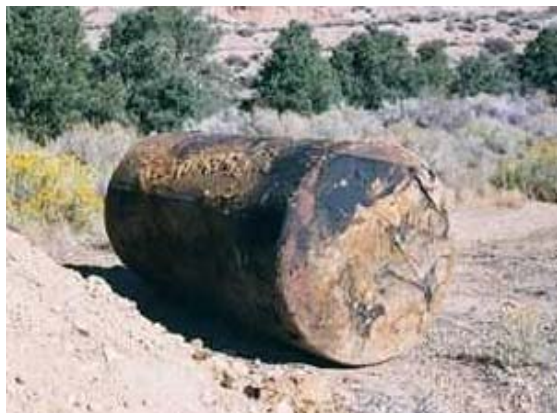
Figure 3. Underground storage tank at the Veta Grande mine site. As of 10-15-2001, this tank has been removed from the site.

excavate an empty underground storage tank. Over 700 cubic yards of debris were delivered to a local metal recycling firm or properly disposed of in a landfill. The empty underground storage tank was removed (Figure 3) and a soil sample was collected from below the tank. Analytical results show hydrocarbon levels were below Nevada Division of Environmental Protection action levels.

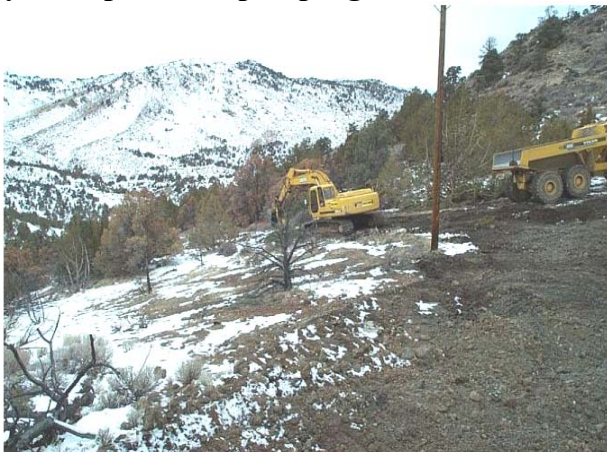
Cyanide pit cleanup in progress.

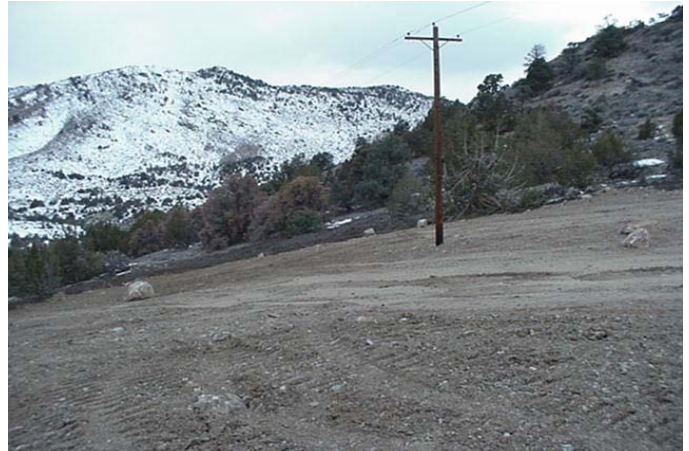
Cyanide pit cleanup is complete. Pit has been covered with a liner, which was buried under fill dirt, then seeded.

◆ On December 10, 2001, Environmental Quality Management Inc., of Lynnwood, WA., began earth-moving operations at the cyanide pit. Contaminated soils were removed from the cyanide pit and transported to an interim storage facility on-site, encased in thick, impervious plastic. The cyanide pit area was excavated down to the bedrock, partially backfilled with fill dirt obtained on-site, covered with an impervious plastic liner and an additional layer of fill dirt which has been contoured and seeded with native species. Cyanide pit reclamation was completed on Sunday, December 23, 2001.
